Contract Report GL-95-1
September 1995

Acoustic Emission on Cofferdam Distress Warning System and Ancillary Acoustic Emission Monitoring; Melvin Price Locks and Dam (Phase III)

by Ground Engineering, Inc.

Final Report

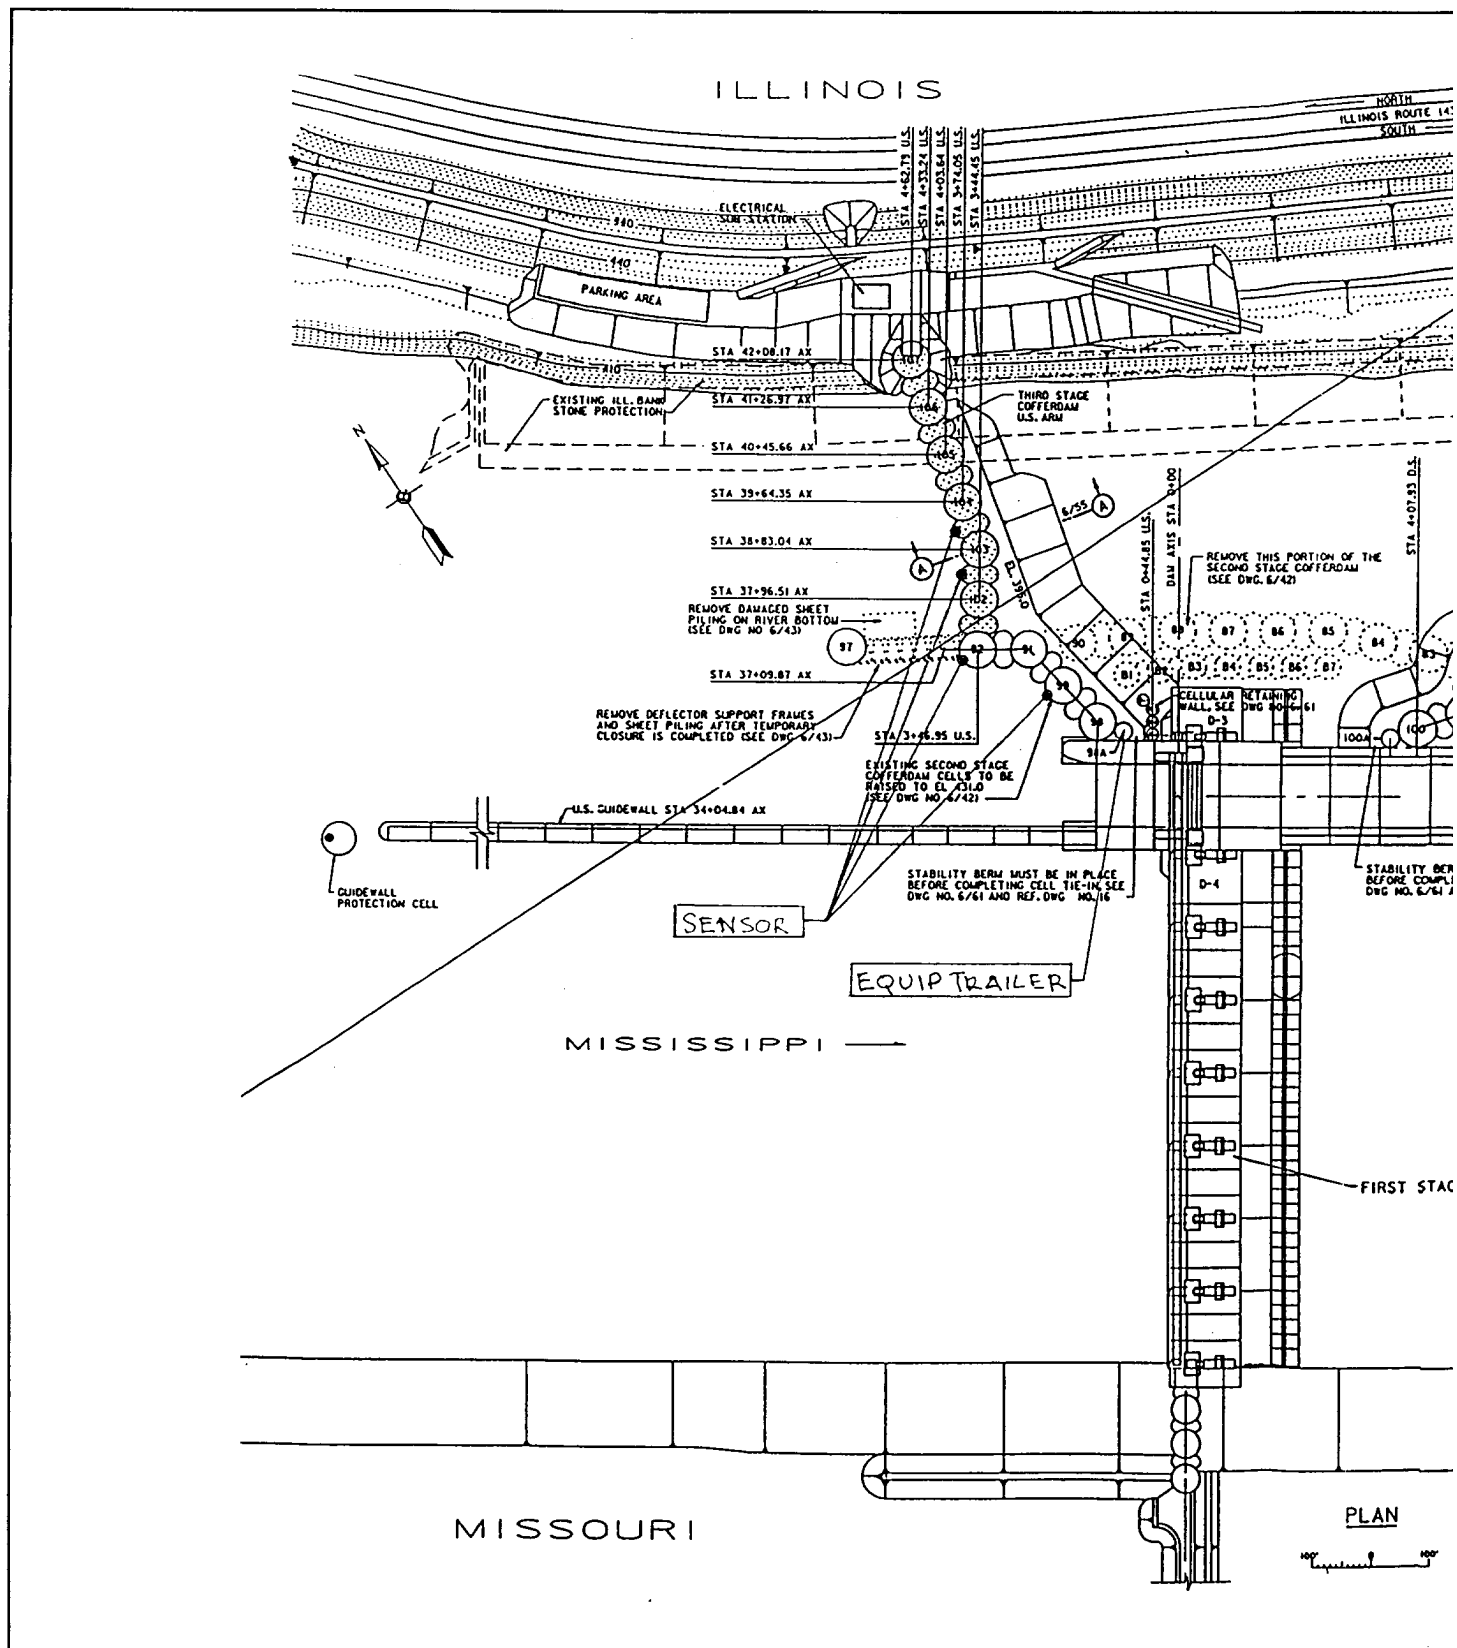
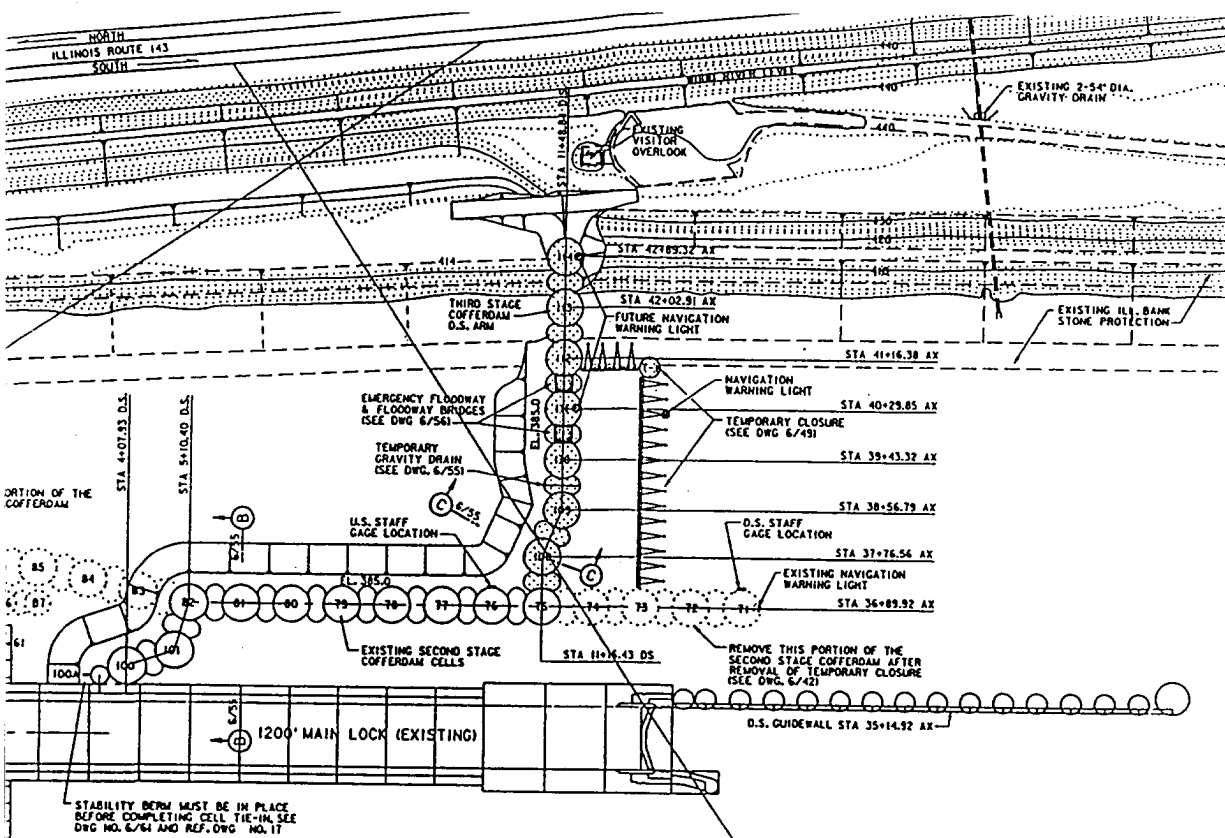
Figure 1. Site plan

The DWS was installed on the north leg of the cofferdam. The equipment trailer was located on Cell 98A, see Figure 1, and Photo 4, and the sensors were located on cells 99, 92, and the Connecting Arcs between Cells 102-103 and 103-104. See Figure 1 and Table 1 for more specific location details. As indicated above the original plan had been to locate sensors on every other cell. This would have resulted in sensors located on Cells 99, 92, 103, and 105. However, the Construction Contractor established a sand unloading operation in the area from the Illinois shore to the Connecting Arc between Cells 104 and 105. In addition, concrete for the upstream guidewall was placed via conveyor from Cell 104. As a consequence of these construction operations the sensor locations given above were selected as the most suitable.

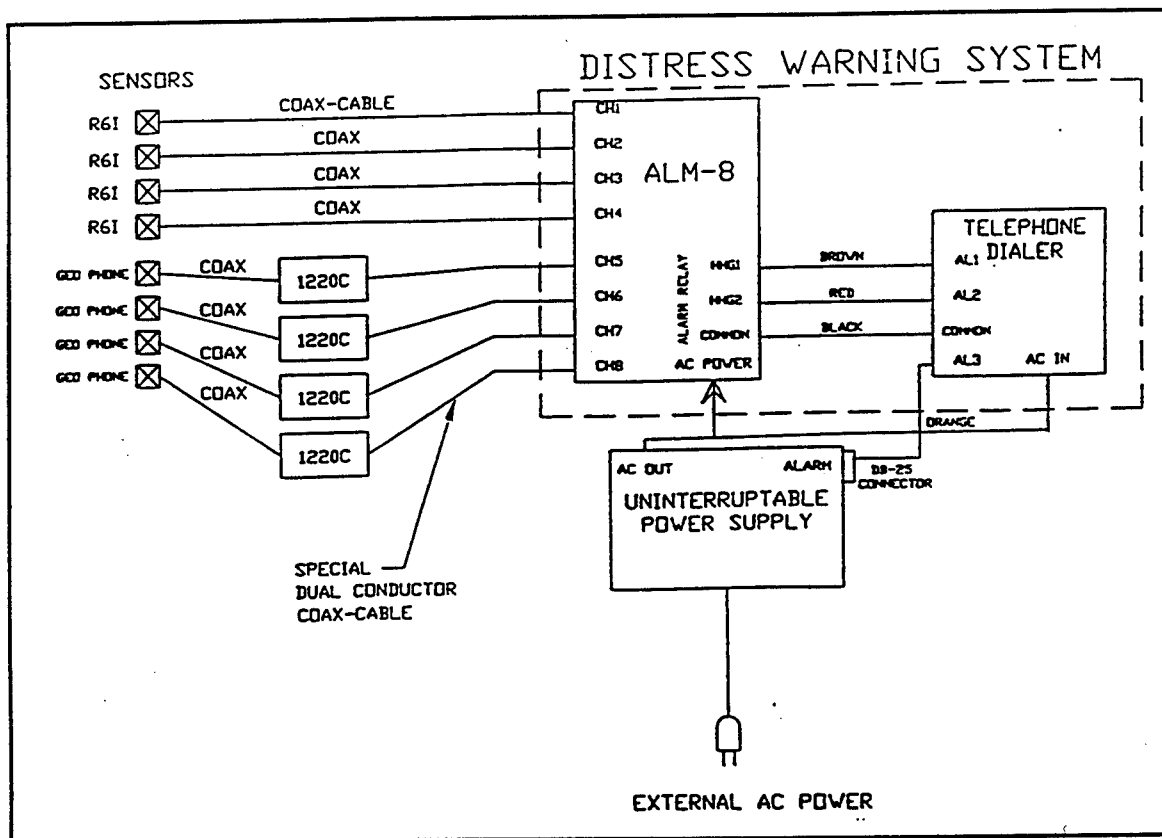
Figure 2. Distress warning system schematic design

A schematic system design is given in Figure 2. It is based on the system described in Sections 9.4 and 9.5 of the September 1989 report. As shown in Figure 2 the DWS monitored four locations. Each monitoring station included a 60 KHz AE sensor, such as was used in the preceding studies listed above, and a geophone. The function of the AE sensor was to record signals generated by high river levels (large hydrostatic forces) and/or damage to a cell from rupture, leakage of cell fill, etc. The function of the geophone, which is a very low frequency sensor, was to record signals generated by an impact on a cell such as from a runaway barge. Such an event would be similar to the large low frequency movements of a seismic event for which geophones are the detection device of choice. The proposed location of the monitoring stations was on every other cell, or approximately 180 ft apart. This spacing was selected because it was believed that the physical events which would generate an alarm would propagate at least half this distance. The AE signals detected by the sensor and/or geophone were carried to the DWS Unit by connecting cables. The DWS Unit, in turn, transmitted a warning message to the Control Room of the Main Lock by telephone.

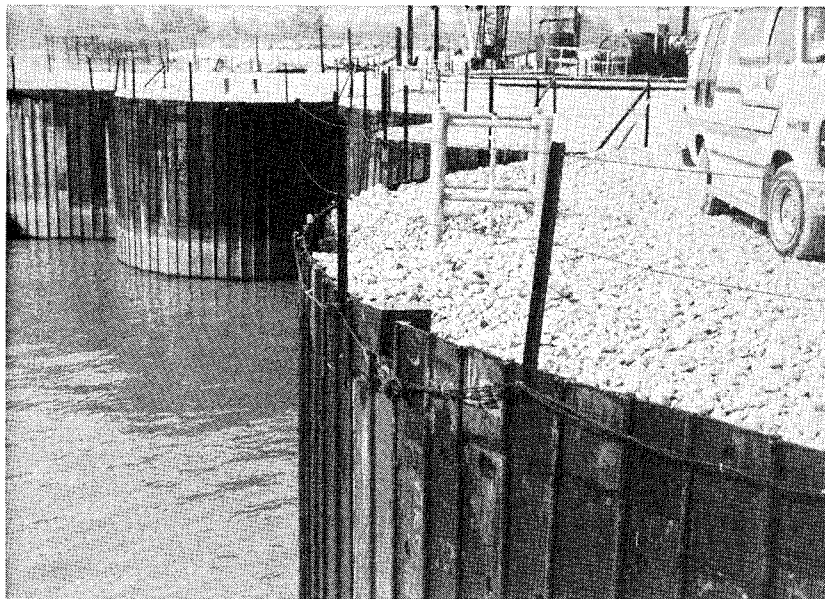
Photo #5 - Sensor Enclosure Box & Connecting Cables

At each location the AE Sensor, Geophone and Preamplifier were housed in a specially fabricated box attached to the top of the sheetpile cell wall. The boxes were painted red to make them clearly visible. See Photos 5 and 6. The AE Sensor was attached to the sheetpile with a specially fabricated magnetic holddown. Before attachment the sensor face was coated with silicone grease to provide complete contact. In addition the joint between the sensor and the sheetpile were caulked with silicone to prevent the entry of water. The Geophones were bolted to an angle which was in turn clamped to the sheetpile. See Photo 7. The Geophones have an integral level bubble and must be installed level. The clamp arrangement permitted sufficient adjustment to accomplish this. The Preamplifiers were also supported by an angle and clamp arrangement. Table 2 provides a summary of AE Sensor, Geophone, Preamplifier, and Cable Number for record purposes. It also provides

The connecting cables were attached to the posts of the guard rail which followed the configuration of the sheetpiling. At each post the cable was attached to a screw clamp with a cable tie. The screw clamp was, in turn, attached to the guard rail post, see Photo 5. Waterproof red plastic tags were attached to the cables approximately every 6 to 8 ft to alert construction workers and others that the cables were not to be disturbed. The tags had the message "TEST CABLE" printed on them.
